Intrauterine Device Malposition Into The Bladder with Stone Formation

Kuncoro Adi¹, Gugum Indra Firdaus¹

Department of Urology, Faculty of Medicine Universitas Padjadjaran / Hasan Sadikin
Hospital Bandung

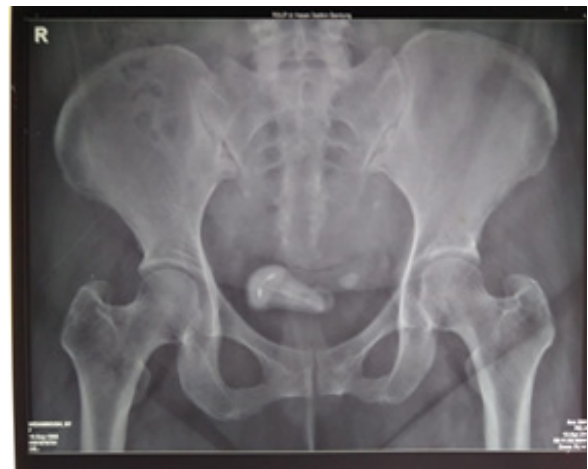
Figure 1 Pelvic x-ray examination

A female patient, 50 years old, complained of painful urination approximately 1 year ago. The pain appeared intermittently. Patient had a history of intrauterine device usage approximately 10 year ago and the device has not yet been removed until the present day. There were no red-colored urine and no stones passed during urination. There were no complaints of fatigue, swelling of extremities, shortness of breath and decreased consciousness. Previous pelvic x-ray examination had found an IUD in pelvic region.

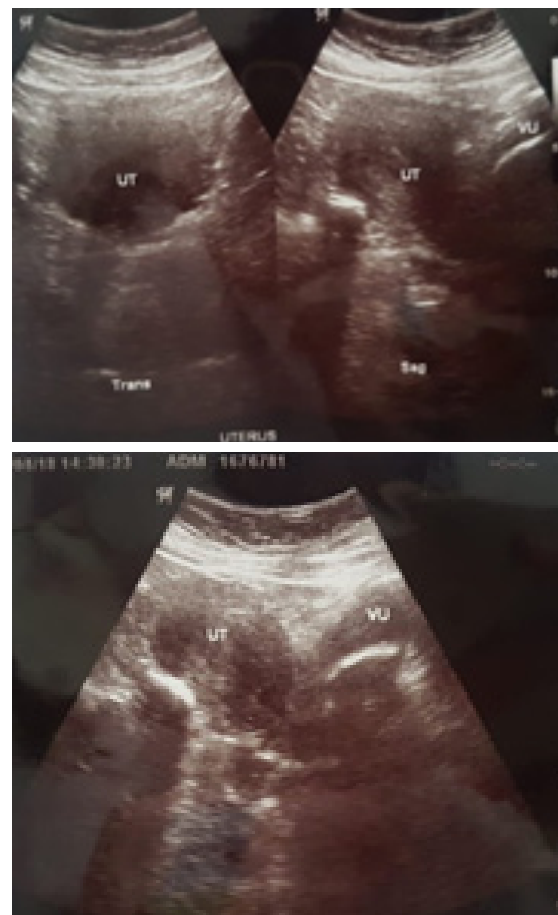
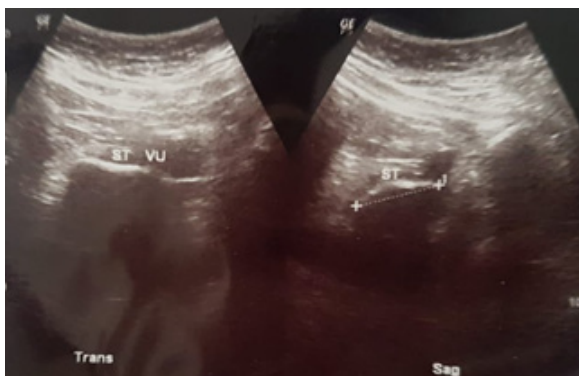
Figure 2 Abdominal ultrasonography of the uterus and kidneys

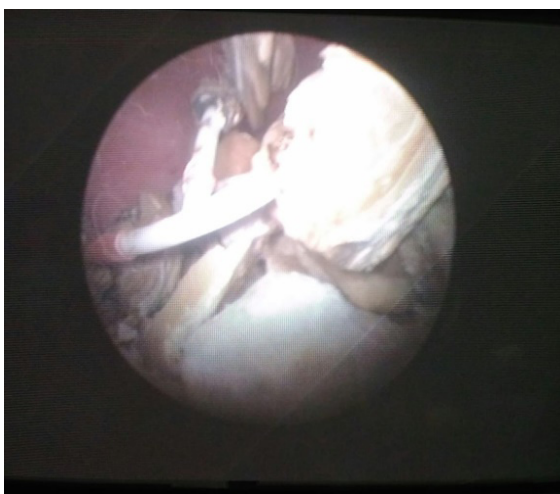
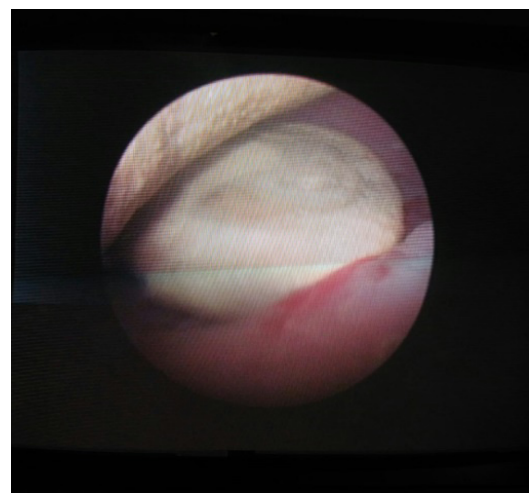
Figure 3 Cystoscopy and pneumatic litotripsy were performed to disintegrate encrustation.

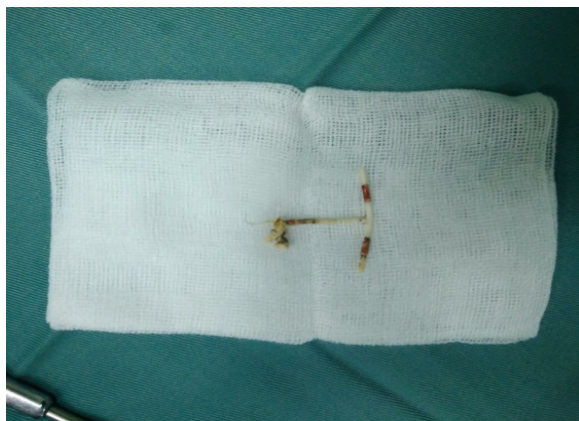
Figure 4 An IUD extracted from the bladder cavity by cystoscopy grasper

Minimally invasive management procedures may be used in treating IUD migrations. After confirmation of the IUD in bladder, laparoscopic removal of an intravesical IUD and stone (if calculi formation was found) should be performed. A case report had successfully removed the adhesions, IUD, and bladder stone via laparoscopic partial cystectomy. The bladder was closed using fine absorbable 4.0 sutures in two layers. The case had not found any leakage after the bladder was filled with approximately 200 mL isotonic NaCl.¹ Another case report had successfully removed the stones with laser lithotripsy and removed the IUD with laparoscopic extraction of the device from the bladder. The availability of minimally invasive surgery for this case meant that open surgery may not longer be necessary in order to manage such cases.^{4, 7, 11}
